Manhole Inspection Summary

Manhole # S21K__029MH

Insp Date: **4/3/08 1:36 PM**

Location Address: **344 s fulton av**

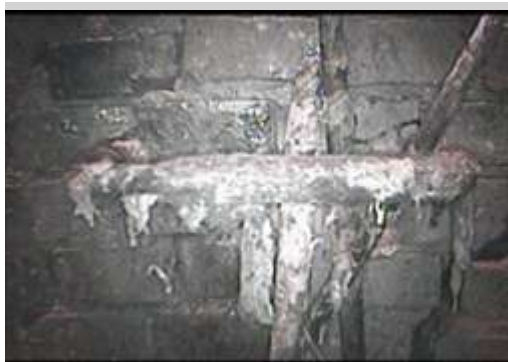
Defect 5

Surcharge ☒ **Evidence Of Surcharge** Depth: **4** (ft.) ☐ Active Surcharge Present

evidence of surcharge

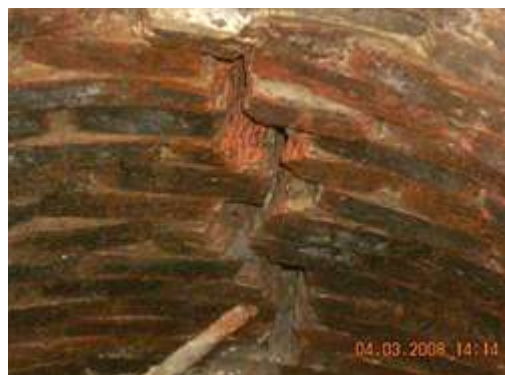
Defect 4

Comments **significant fracture in barrel wall and multiple cracks throughout the structure**

Condition: ☐ Sound ☒ **Cracked** ☐ Root Intrusion ☐ Loose Brick ☐ Deteriorated

fracture/crack in barrel wall

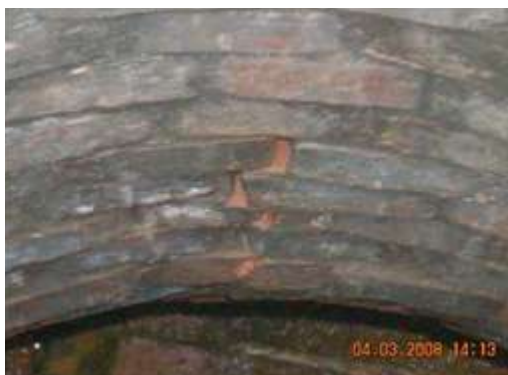
Defect 3

Condition: ☐ Sound ☒ **Cracked** ☐ Root Intrusion ☐ Loose Brick ☐ Deteriorated

crack in corbel wall near barrel joint

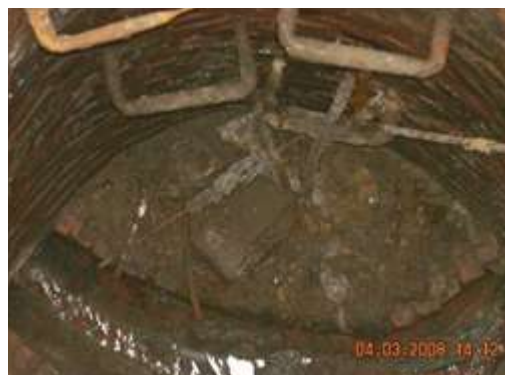
Defect 2

Condition: ☐ Sound ☐ Cracked ☐ Root Intrusion ☐ Deteriorated ☐ Leaks ☒ **Debris**

debris on bench

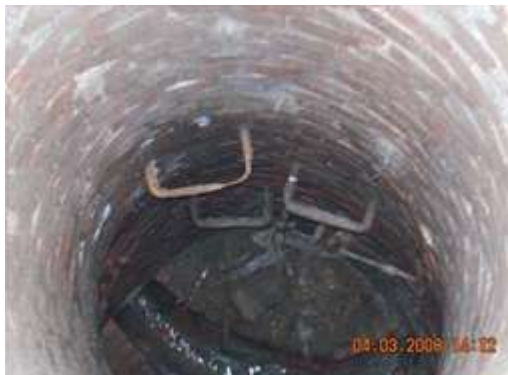
Defect 1

Steps Count: **4** Missing: **3** ☒ **Corroded**

corroded steps

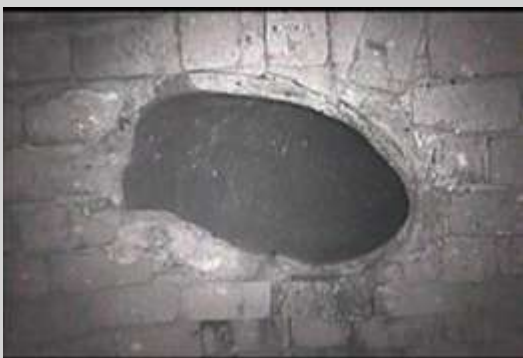
6 O'Clock Inflow

Pipe Height: **8.4** (in.) Rod and Bar (Angled)
Pipe Material: **Clay** ☐ Pipe Lined
Invert Depth: **8.49** (ft.) Flow Characteristics: **Fast**
Deposits: ☐ None ☐ Mud ☐ Sludge ☐ Debris ☒ Grease
Silt Depth: **1** (in.) Deposits Extent: **Light**
Infiltration: **None** Pipe Seal Cond: **Sound**

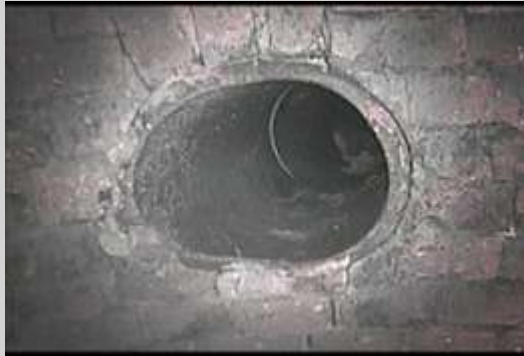
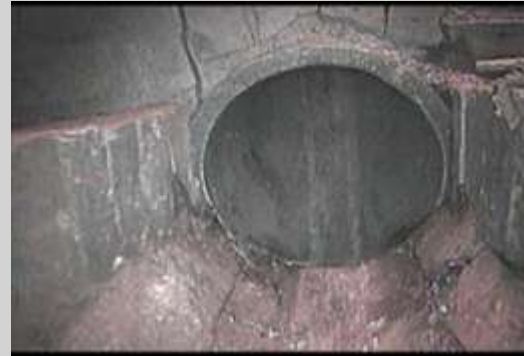
9 O'Clock Inflow

Infiltration: **None** Pipe Seal Cond: **Cracked**
